**1326 AND 1330 COUNTY ROUTE 7 FEASIBILITY STUDY
FOR
ANCRAM OPERA HOUSE THEATER, INC**

EXISTING CONDITIONS PHOTOGRAPHS AND DRAWINGS

EXISTING CONDITIONS PHOTO SURVEY
THE ANCRAM OPERA HOUSE AND 1326 COUNTY ROUTE 7

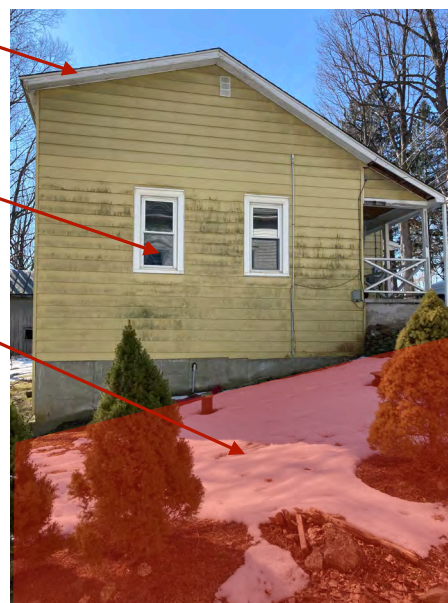
North Elevation

CREATE NEW ROOF LINE

**OPEN ACCESS TO NEW
CONNECTING PORCH**

**AREA FOR NEW
CONNECTING PORCHES**

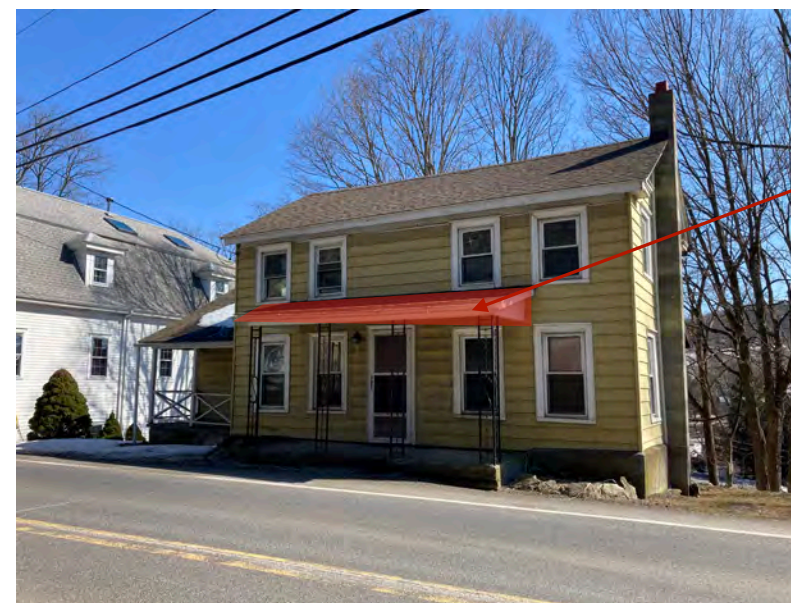
West (Front) Elevation

REMOVE CANOPY

NEW OPENINGS

**AREA FOR NEW
CONNECTING PORCHES**

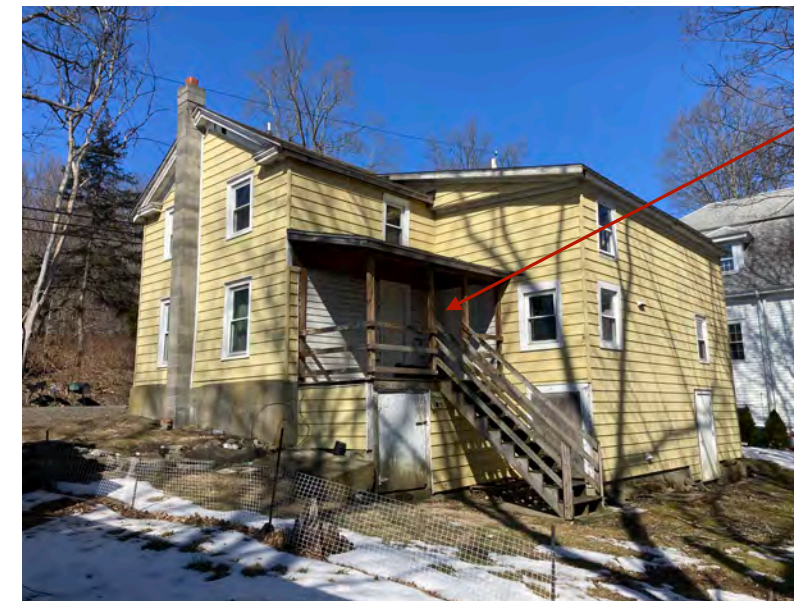
North and East Elevations

NEW BACK PORCH AND ENTRY

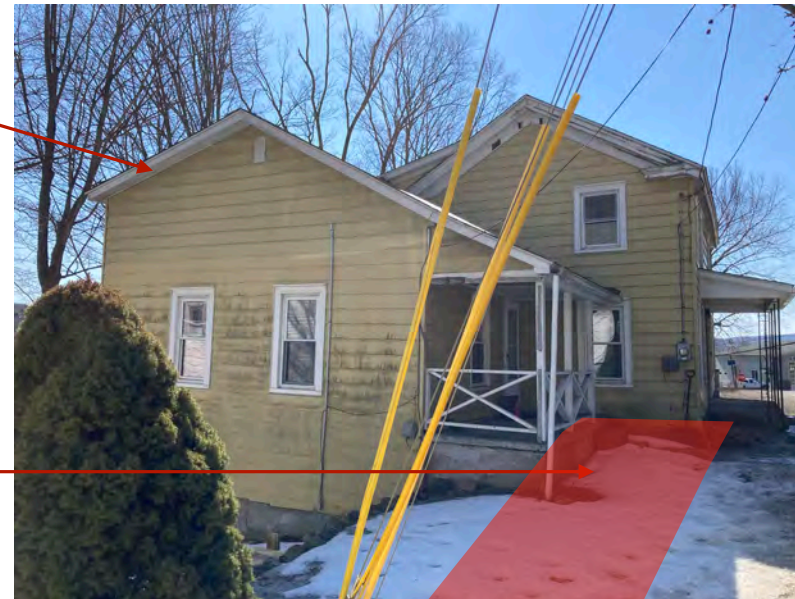
North Elevation

CREATE NEW ROOF LINE

NEW ADA RAMP

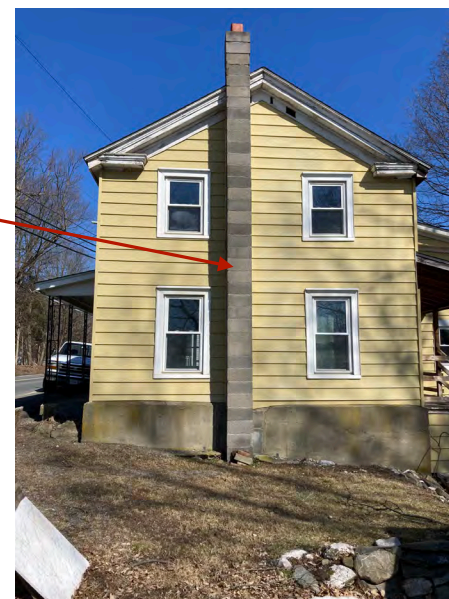
**AREA FOR NEW
CONNECTING PORCHES**

REMOVE CHIMNEY

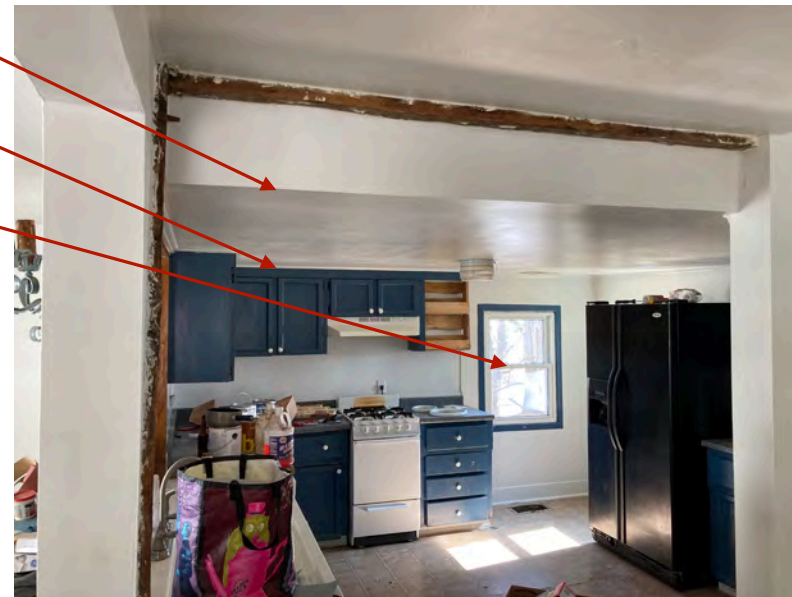
View into Existing Kitchen

- The height of the kitchen ceiling is 6'7" and does not meet code.
- The entrance from the street is not ADA accessible.
- There is no entrance vestibule.
- The front entrance porch on the original section of house was added on and is not symmetrically positioned.
- The second means of egress at the rear of the house opens into the bathroom.
- The door to the basement stair opens into the bathroom.
- One of the upstairs bedrooms is under-sized by code and has no closet.
- There is an abandoned roof over the first floor addition which is a health hazard and must be removed.
- The wooden stair is not stable and needs to be re-built.
- Finishes, fixtures, cabinetry and appliances need replacing.
- The basement level is under-utilized and could be finished out.

- RAISE CEILING
- MAINTAIN LOCATION
RENOVATE KITCHEN
- NEW DOOR FROM
REAR ENTRANCE
PORCH

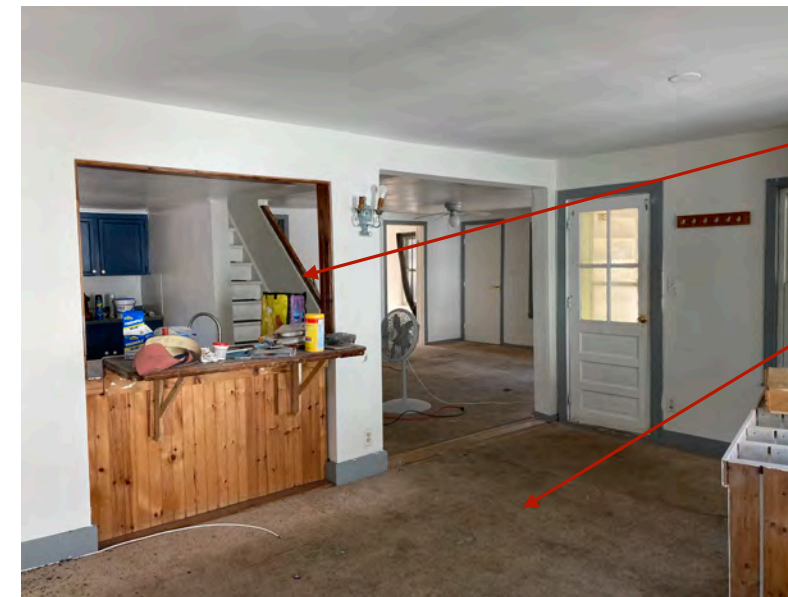
Existing Entry Area

- CREATE A SEPARATE KITCHEN FROM
MEETING AREA
- RESTORE WOOD FLOOR
BOARDS

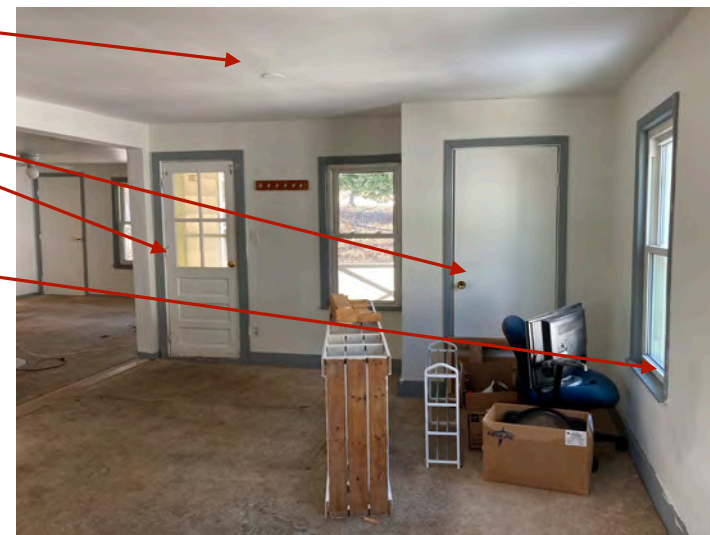
View into Existing Entry

- RAISE CEILING
- NEW SHARED ENTRY
AREA WITH NEW
BATHROOM
AND MEETING SPACE
- PROVIDE ACCESS TO
EXTERIOR

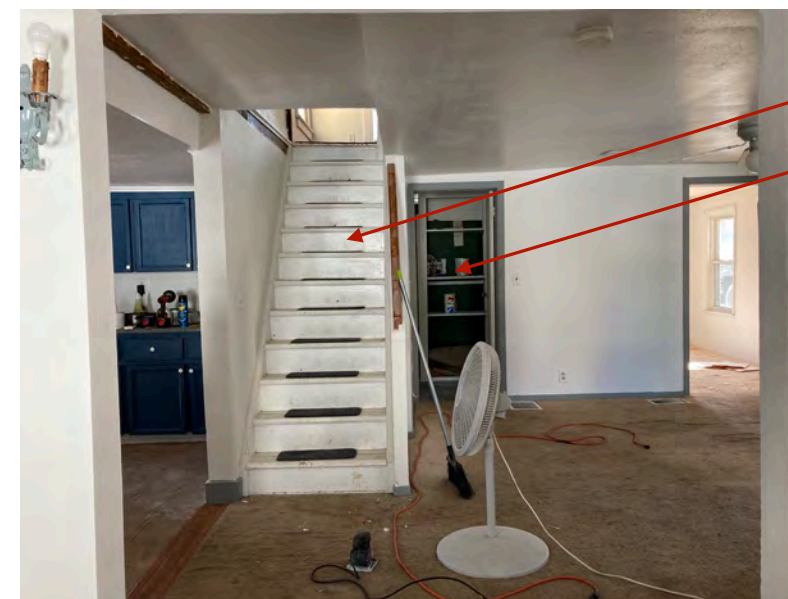
Existing Stair

- NEW STAIR
- CREATE NEW BATHROOM
ENTRY

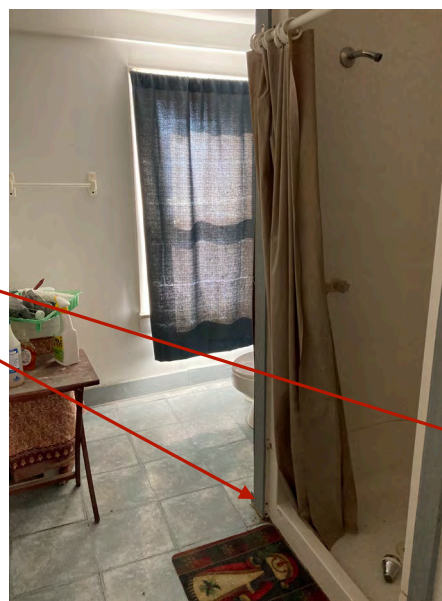
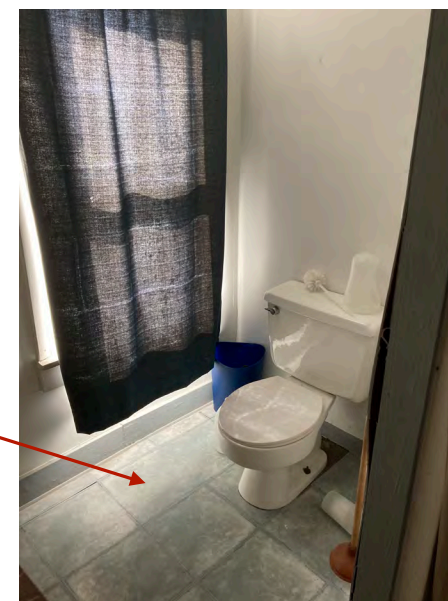
First Floor Bathroom

NEW FIXTURES AND FINISHES

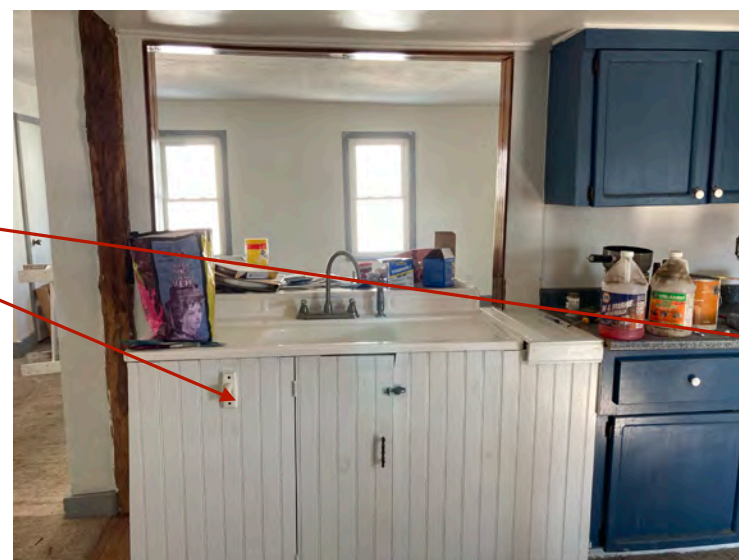
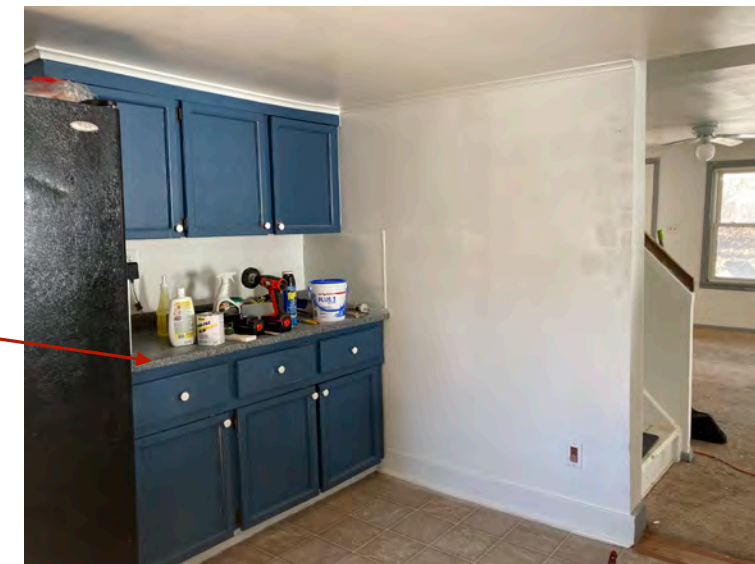
Kitchen

REPLACE CABINETRY
AND APPLIANCES

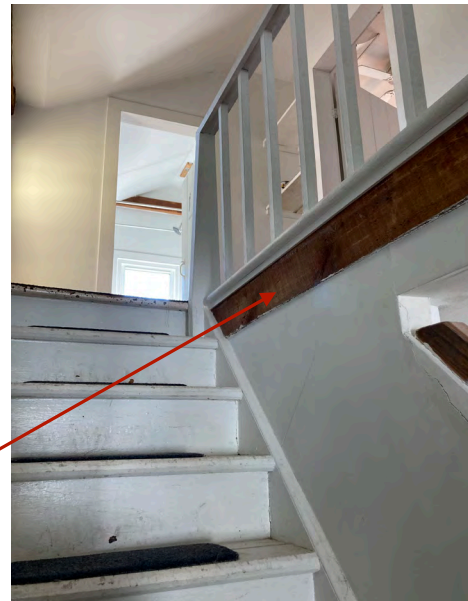
Stair

RETAIN OLD TIMBER POST
AND BEAM FRAMING

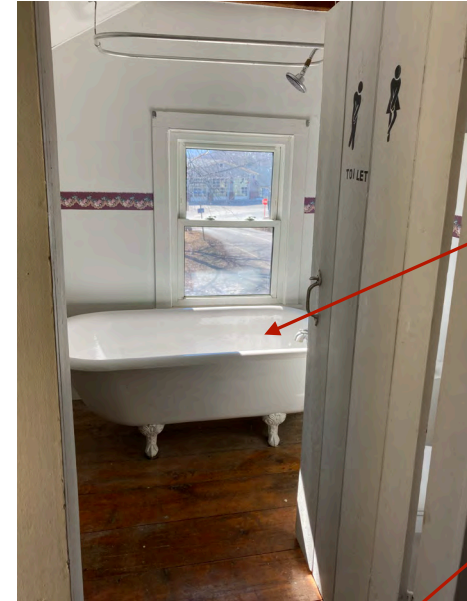
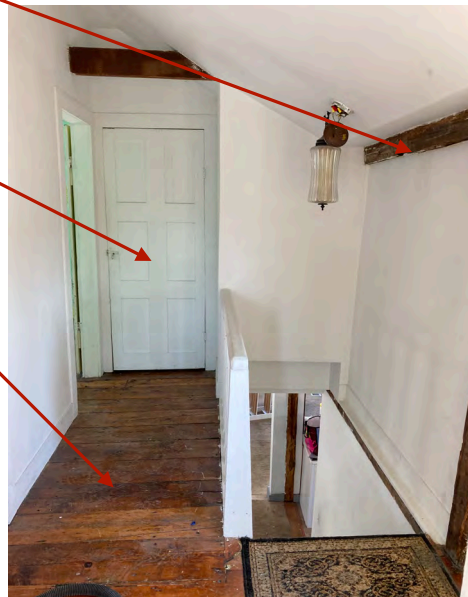
Second Floor Bathroom

RETAIN FIXTURES WHERE POSSIBLE

RETAIN OLD TIMBER POST
AND BEAM FRAMING

SAVE PANEL DOORS
FOR RE-USE

REFINISH WIDE FLOOR
BOARDS WHERE POSSIBLE

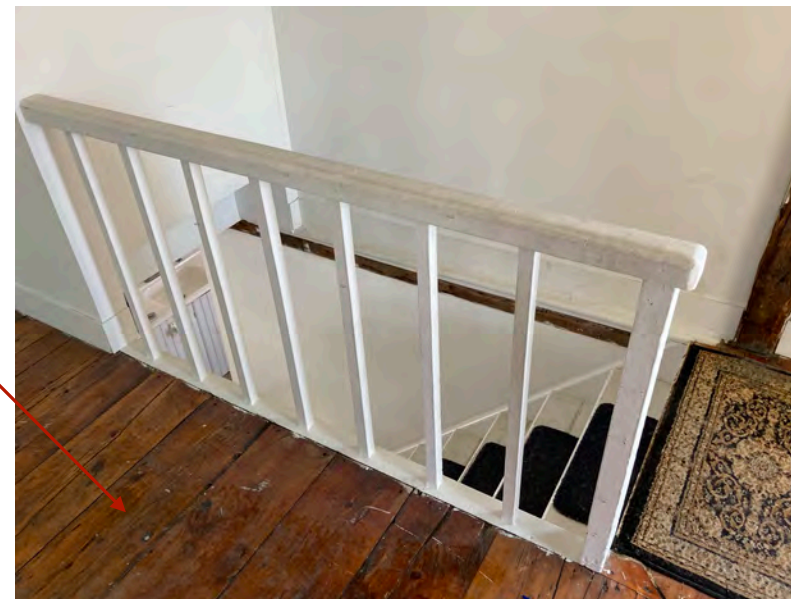
Stair

REFINISH WIDE FLOOR
BOARDS WHERE POSSIBLE

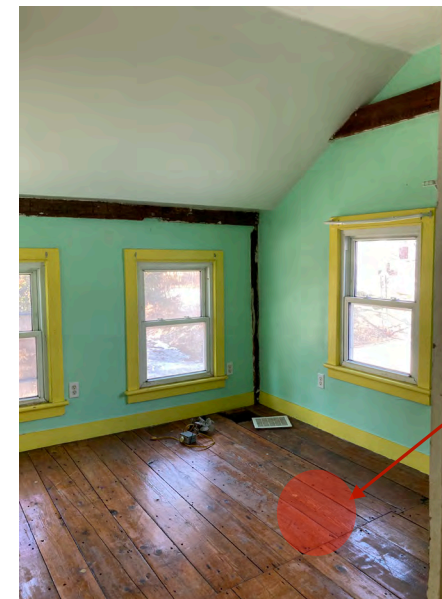
Bedroom

REFINISH WIDE FLOOR
BOARDS WHERE POSSIBLE

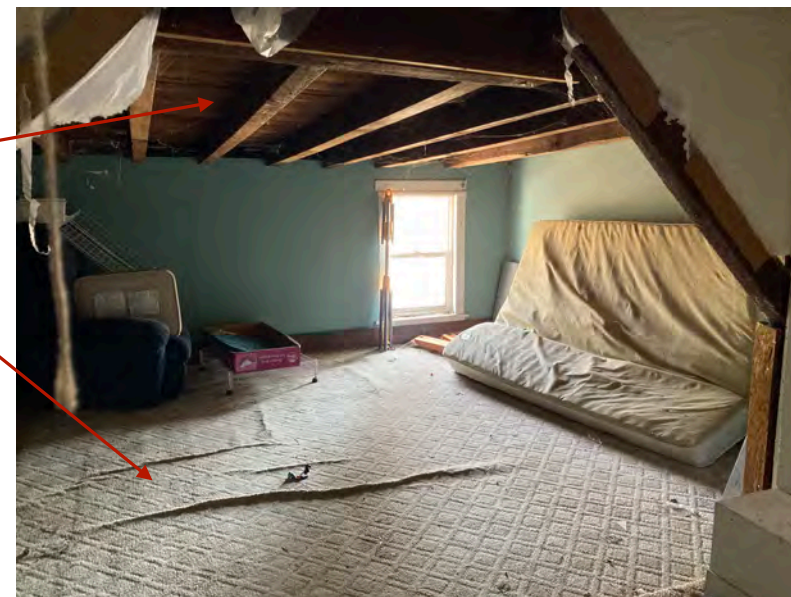
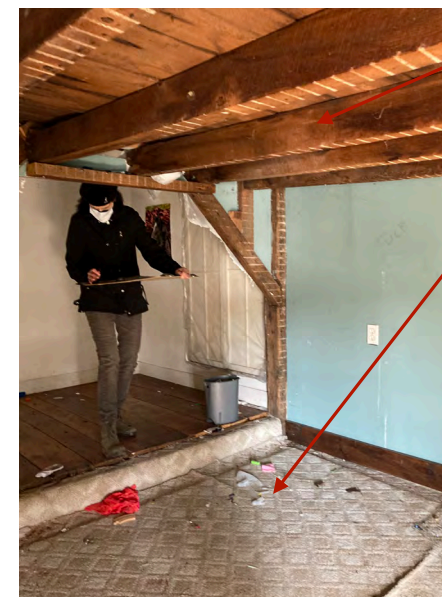
Dormer Storage Area

The ground floor has an open plan and consists of a living/dining area, a kitchen, a full bathroom and a small corner bedroom facing the street. An interior wooden stair leads to a second floor with two bedrooms, a full bathroom and two storage areas. A closed-off storage area over the first floor living room revealed remnants of an abandoned roof structure that will need to be demolished.

INSULATE AND FINISH CEILING
REMOVE FLOOR TO
RAISE KITCHEN CEILING BELOW

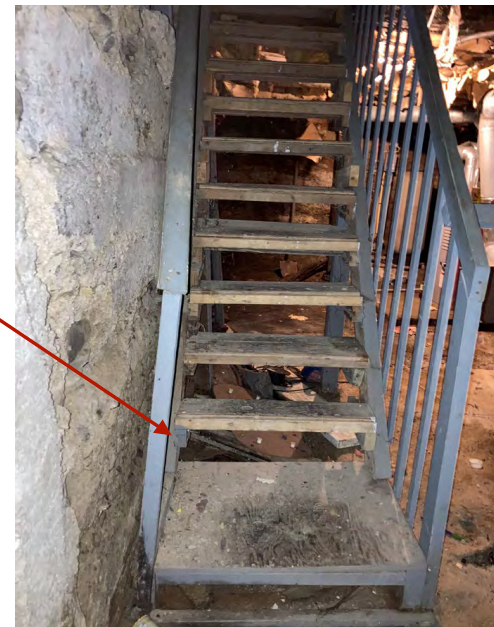
Stair

REPLACE STAIR

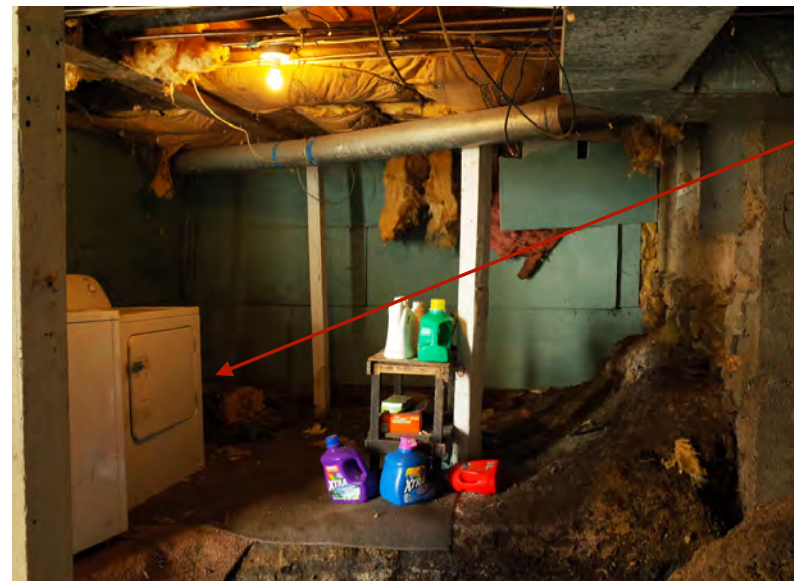
Laundry Area

REMOVE STONE LEDGE AND PROVIDE
NEW LAUNDRY MACHINES

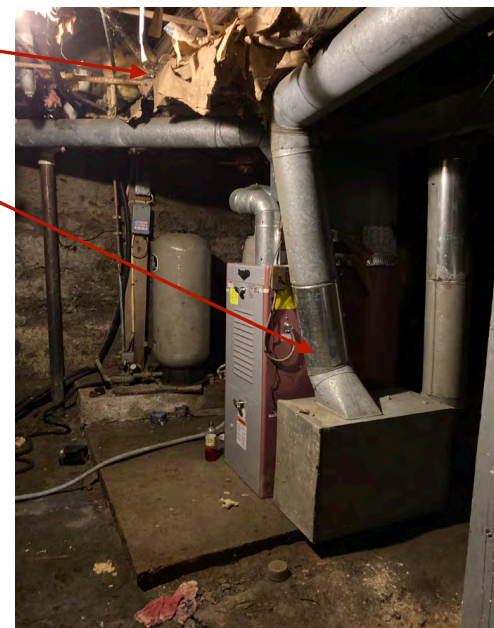
Mechanical Equipment

REFINISH BASEMENT AND
PROVIDE NEW INSULATION
REPLACE FURNACE AND
PROVIDE NEW HYDRONIC
HEATING SYSTEM

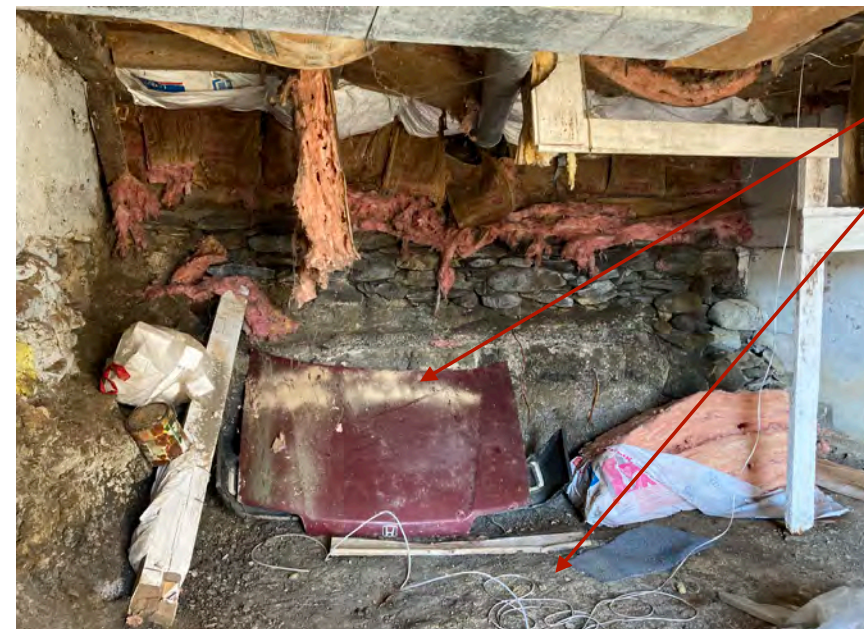
The basement level of the house is accessible from the main interior stair and from the rear garden. This level contains a domestic hot water heater, furnace, pressure tank, and a washer and dryer. The floor is partially dirt, loose stone with some poured concrete under the mechanical equipment. Some portions under the addition are not fully excavated.

REFINISH AND REMOVE ALL DEBRIS,
POUR NEW SLAB, REMOVE LOOSE
STONE

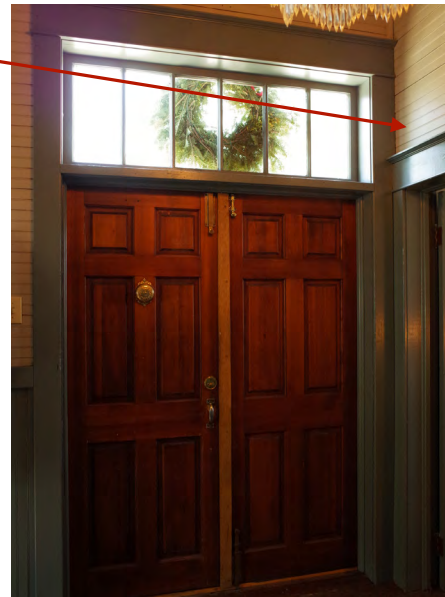
Main Entry Doors

**ENLARGE LOBBY SPACE
PUSH WALL BACK**

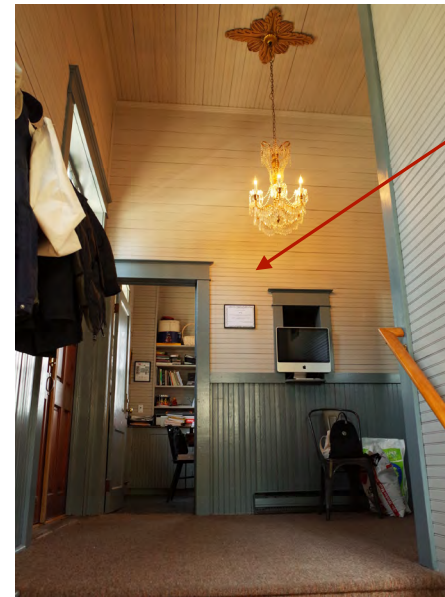
Entrance Lobby looking North into Office

**ENLARGE LOBBY SPACE
PUSH WALL BACK**

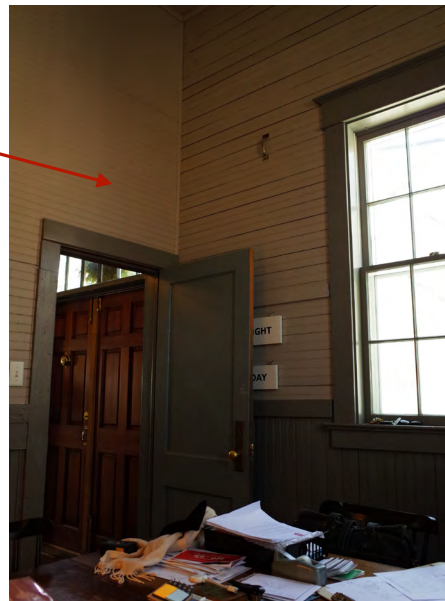
Office Space

**CONVERT TO NEW
ADA BATHROOM
FOR PATRONS**
